**Engineering Report 66535-1****Water Test**

**Data Panel**

<b>Company name</b>	Data Panel	<b>Performed by</b>	JMT
<b>Project number</b>	66535-1	<b>Specification</b>	ISO 20653 (2013), IPX9K
<b>DUT description</b>	Can Splitter	<b>Test date(s)</b>	4/16/2025 to 4/18/2025

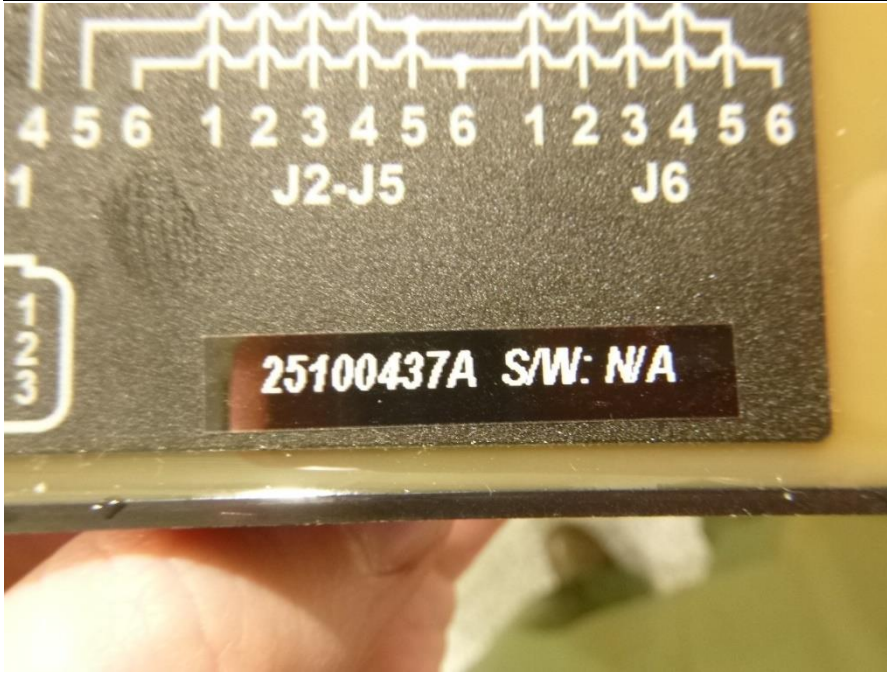
Photograph A-3: Test unit 3 identification

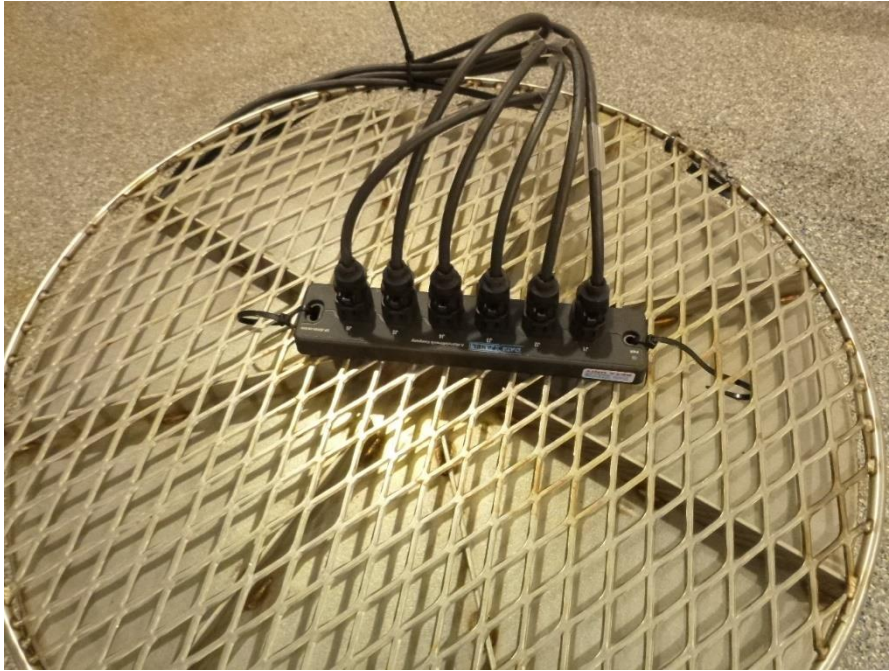
Photograph A-5: Test setup, unit 1

Test log
Test units were mounted to a test stand and subjected to the test conditions specified above.
After completion of exposure, the test units were functionally checked, then cut open and visually inspected for water intrusion.

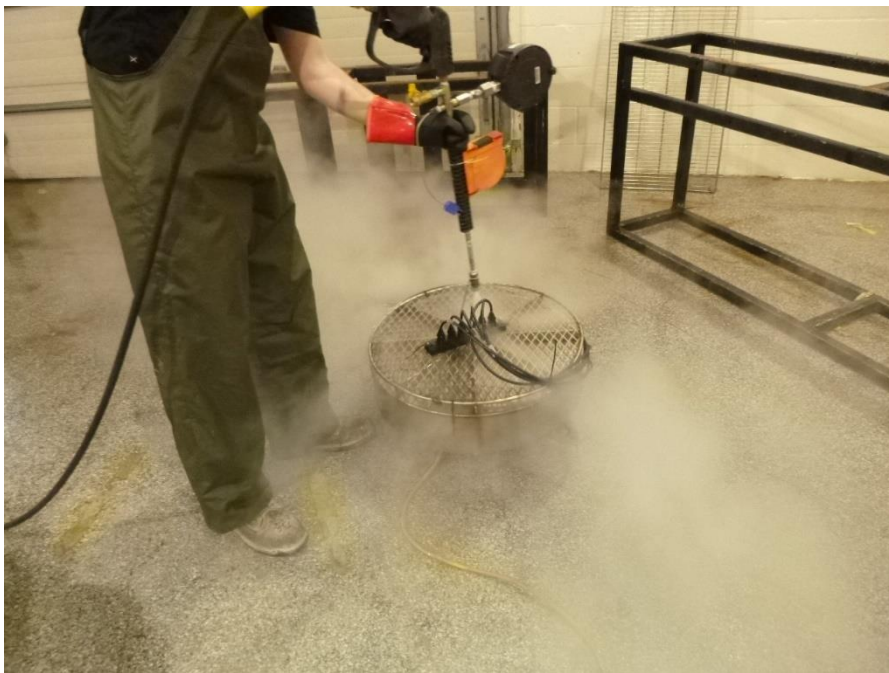
Photograph A-6: Representative view of 90° exposure (unit 1)

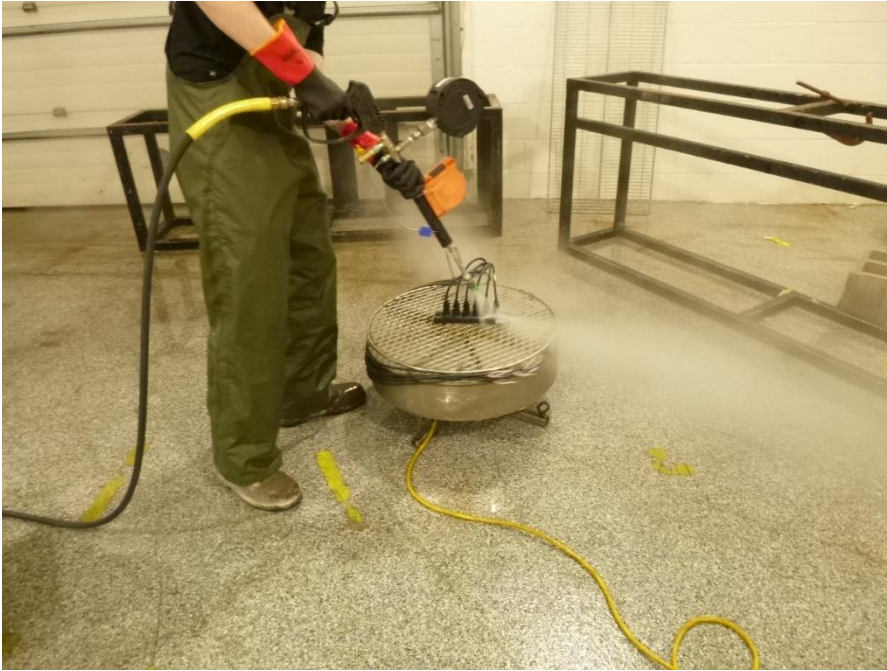
Photograph A-7: Representative view of 60° exposure (unit 1)

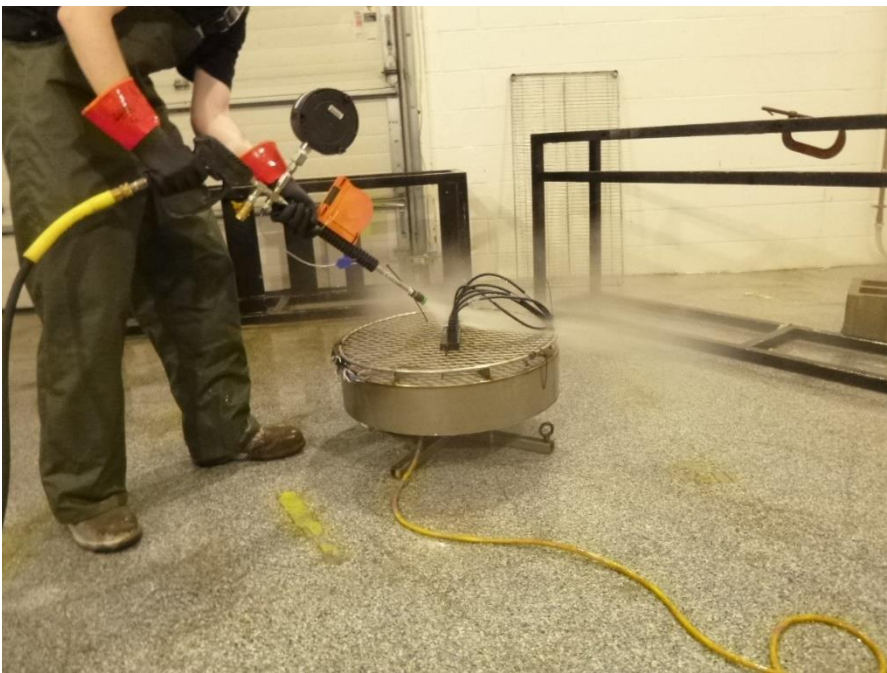
Photograph A-8: Representative view of 30° exposure (unit 1)

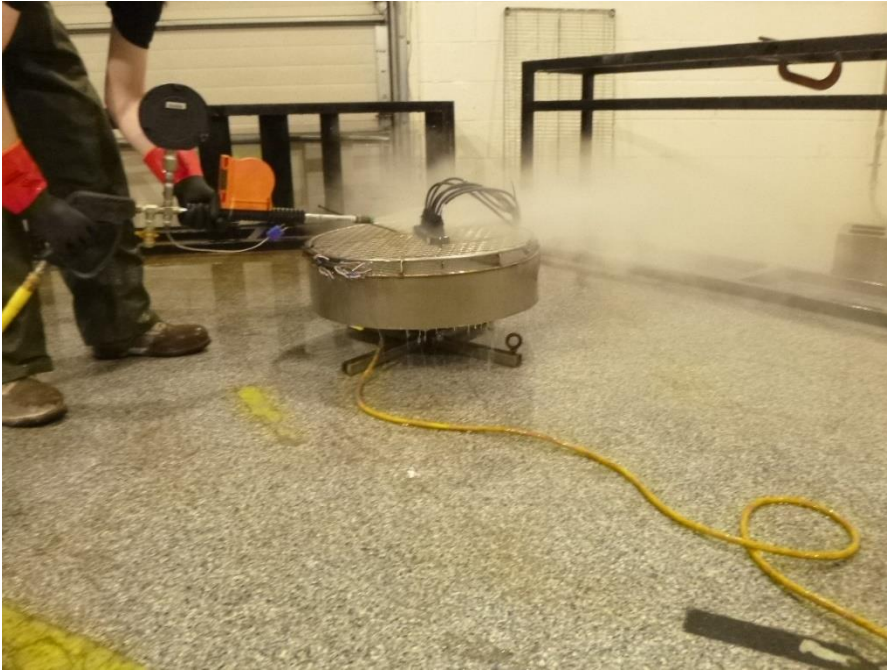
Photograph A-9: Representative view of 0° exposure (unit 1)

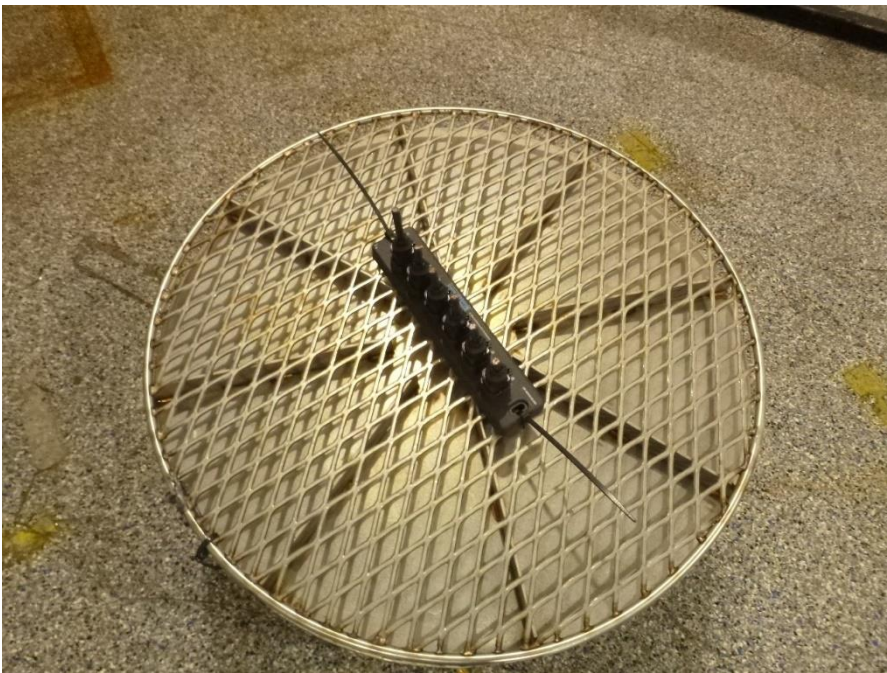
Photograph A-10: Test setup (unit 2)

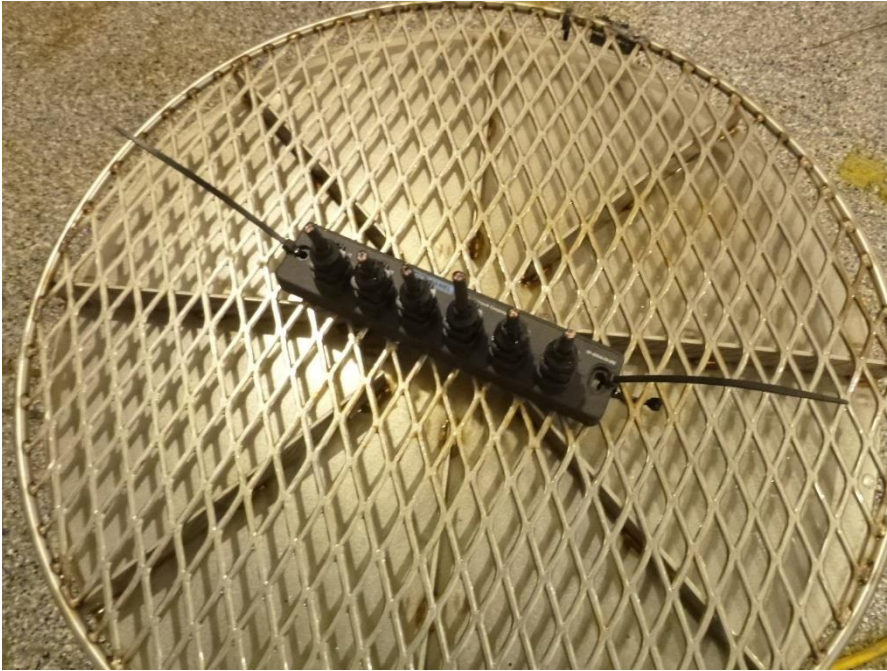
Photograph A-11: Test setup (unit 3)

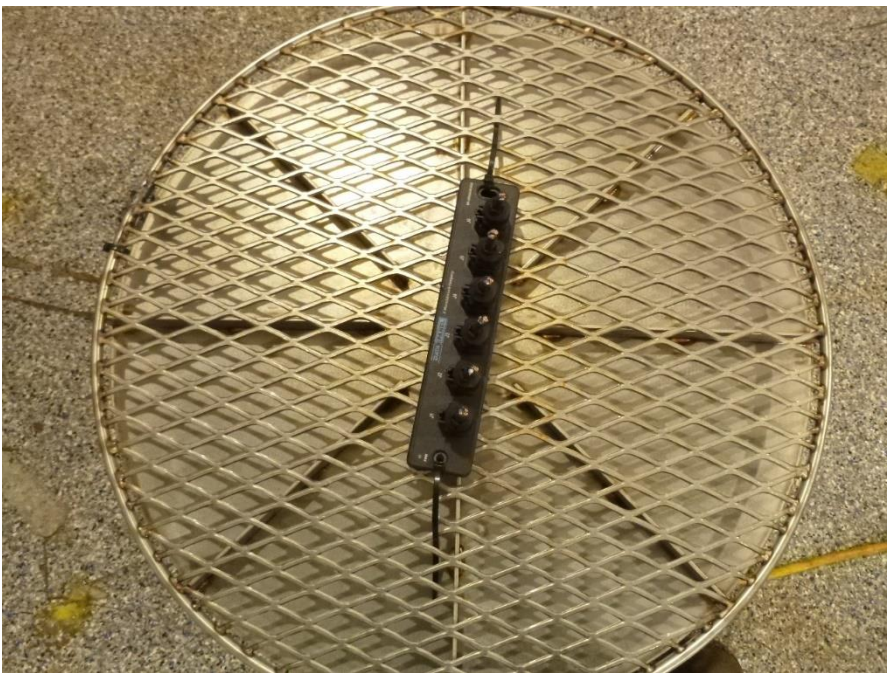
Photograph A-12: Test setup (unit 4)

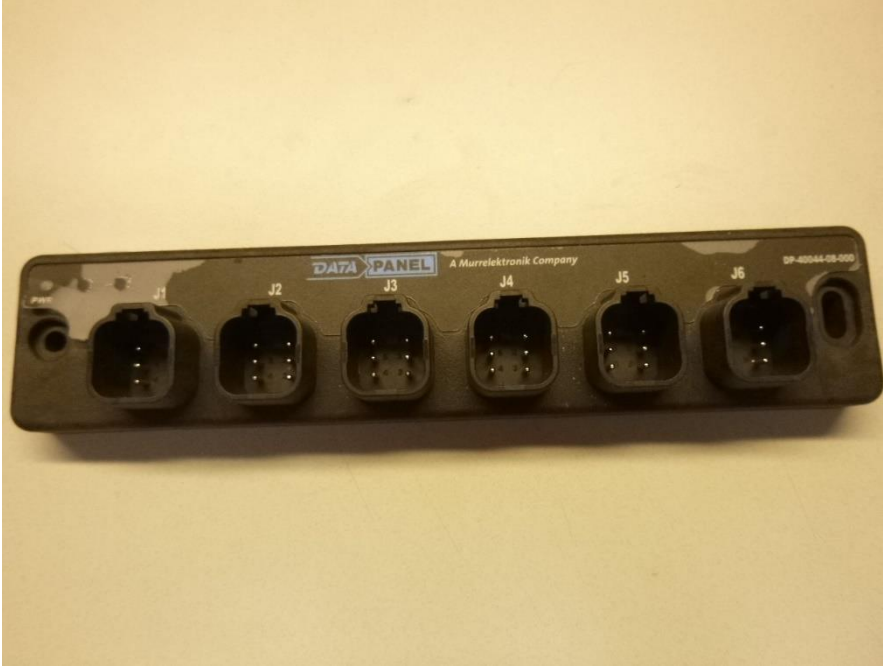
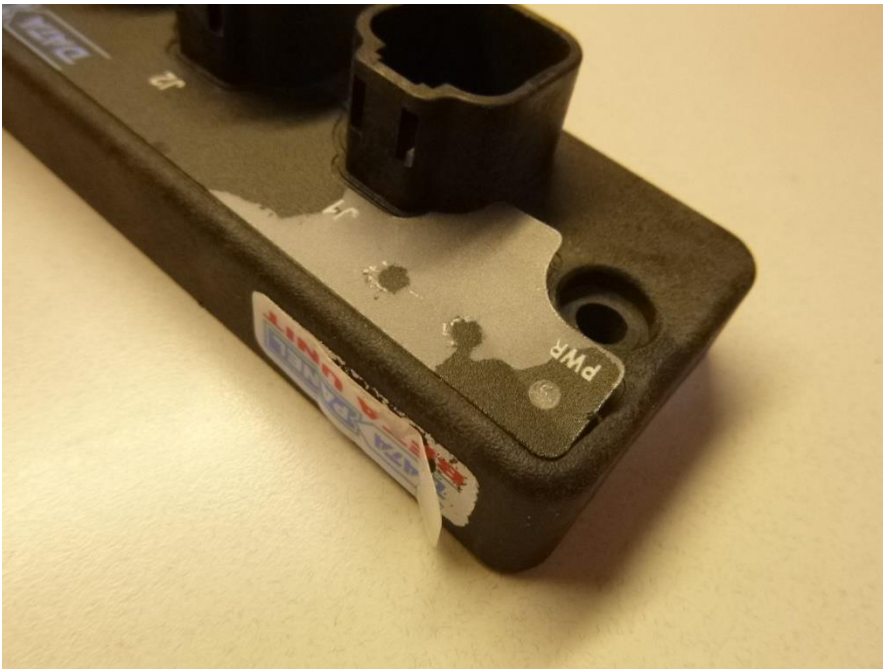
Photograph A-13: Post-test view of test unit 1

Photograph A-14: Post-test view of test unit 1

Results / comments
Visual inspection upon completion of the test revealed:
<input checked="" type="checkbox"/> No water penetration.
<input type="checkbox"/> Water penetration was found (describe here):
<input type="checkbox"/> Other (describe here):
Functional check involved checking the resistance between pins. All resistance between connected pins were < 1 ohm, for all units.
Units showed some peeling of their plastic labels, but otherwise no damage seen.

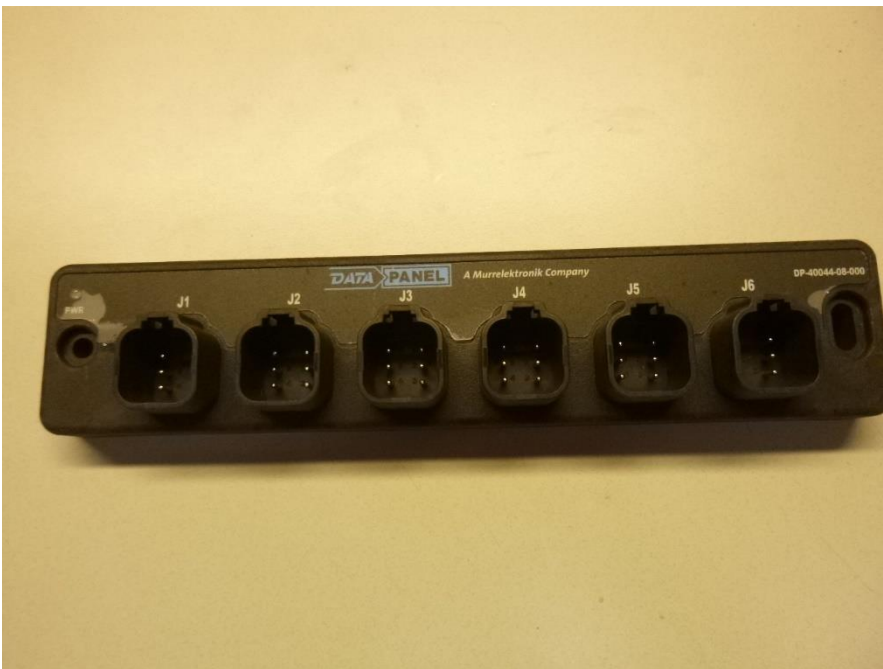
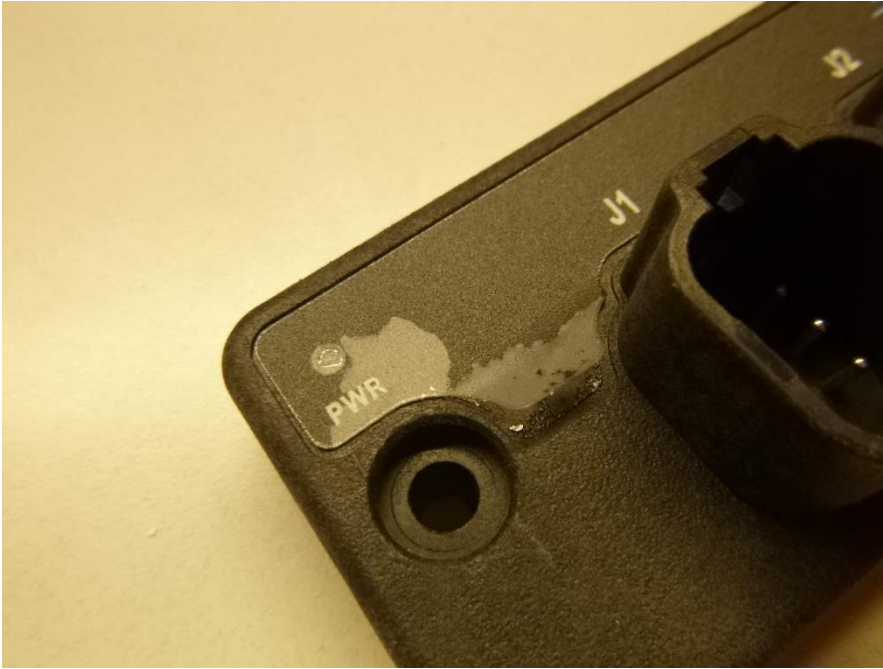
Photograph A-16: Post-test view of test unit 2

Photograph A-17: Post-test view of test unit 2

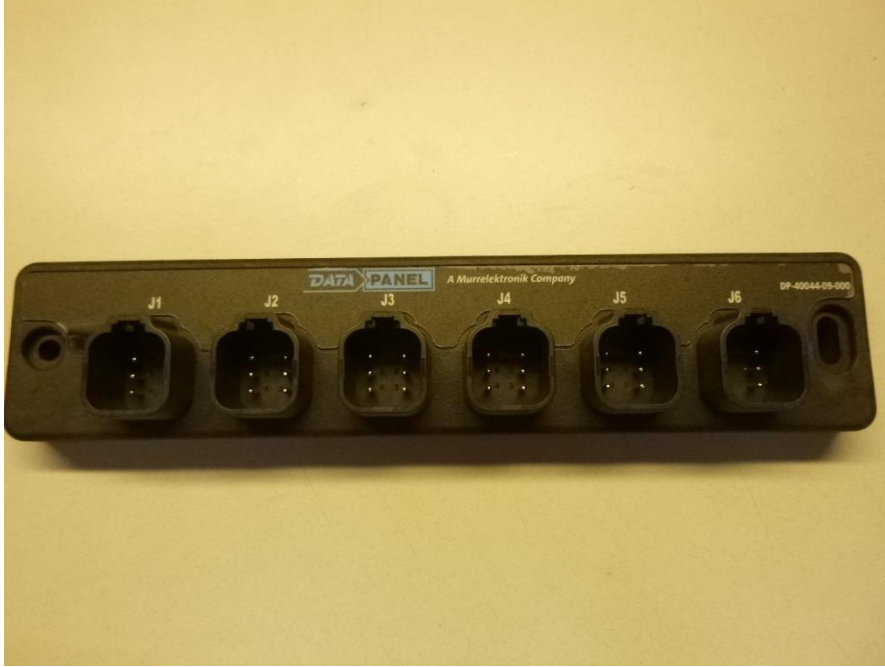
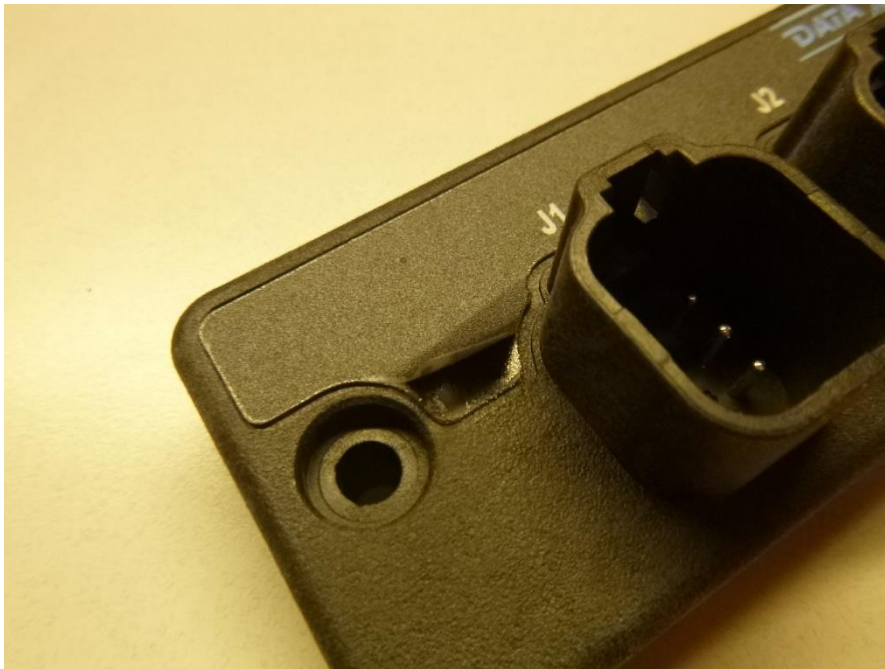
Photograph A-19: Post-test view of test unit 3

Photograph A-20: Post-test view of test unit 3

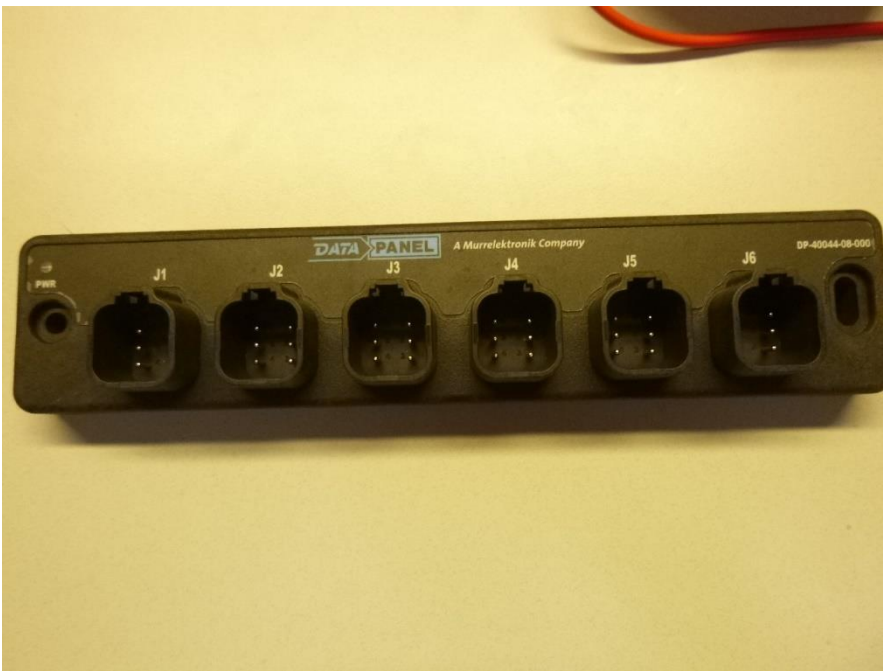
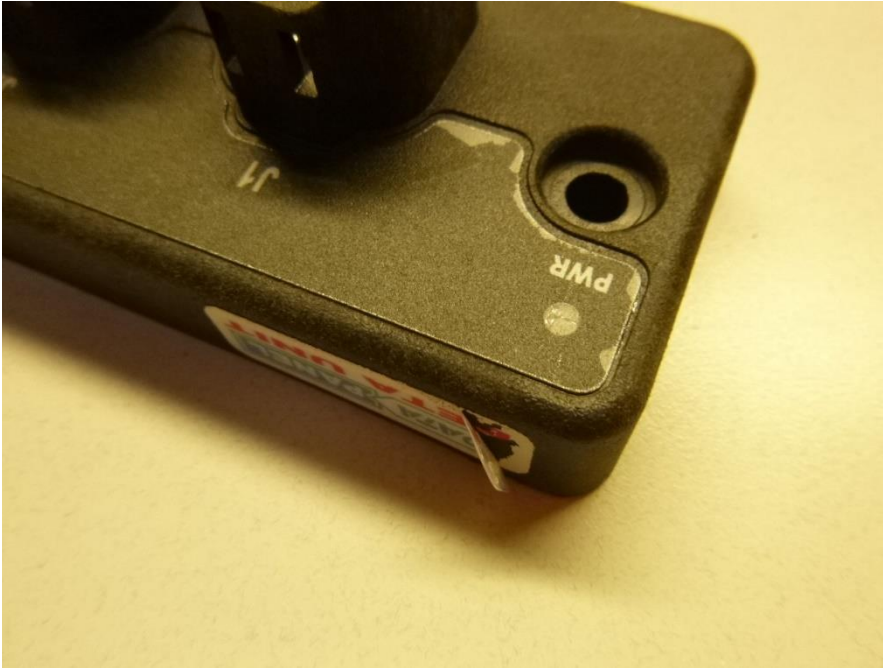
Photograph A-22: Post-test view of test unit 4

Photograph A-23: Post-test view of test unit 4

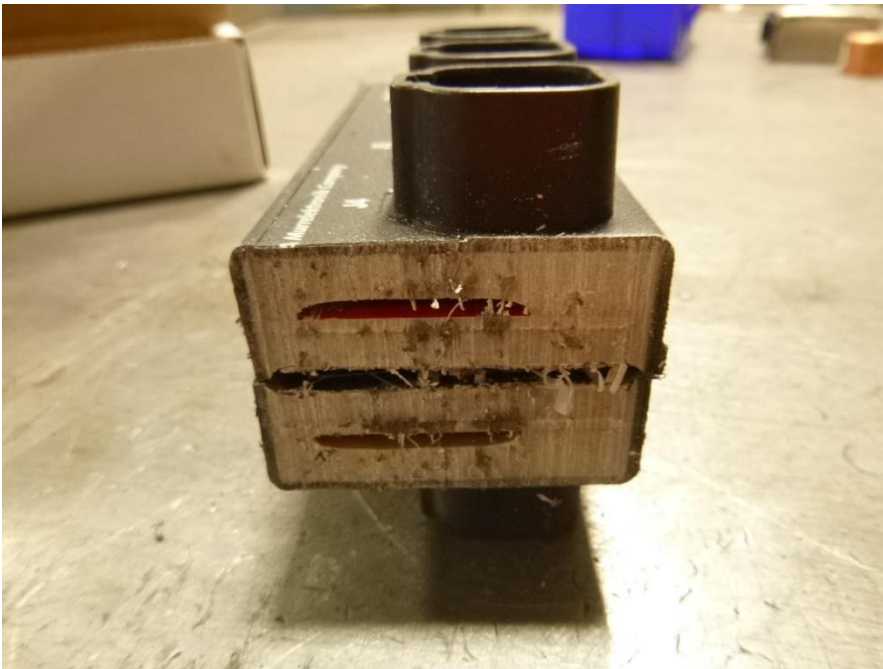
Photograph A-24: Post-test view of test unit 4 interior
