Engineering Report 66535-1 Rev. 1

Water Test

Data Panel

Company name	Data Panel	**Performed by**	JMT
Project number	66535-1	**Specification**	*ISO 20653 (2013), IPX9K*
DUT description	Can Splitter	**Test date(s)**	4/16/2025 to 4/18/2025

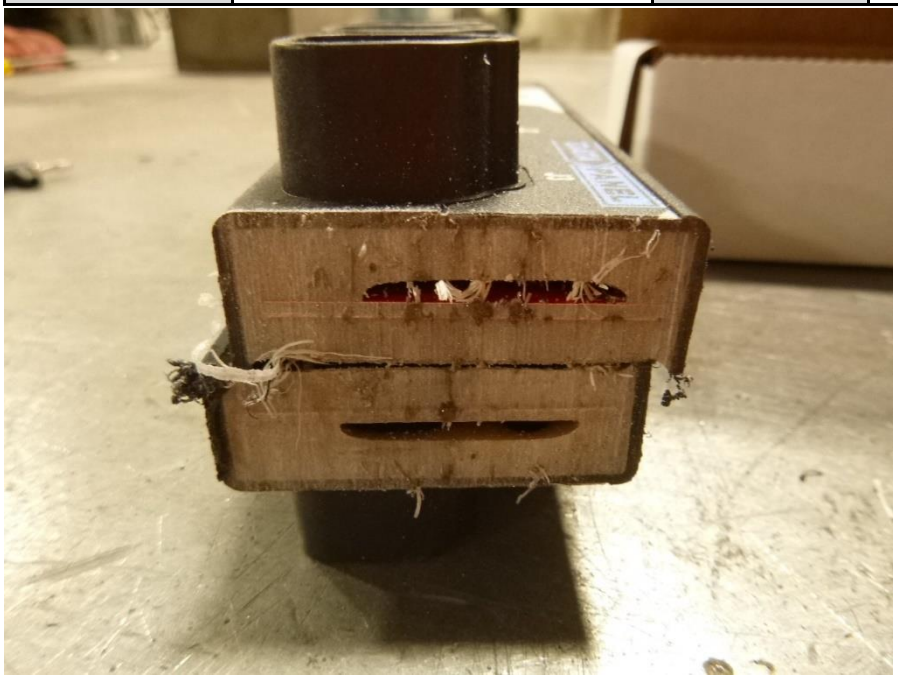
|X| No water penetration.

Functional check involved checking the resistance between pins. All resistance between connected pins were < 1 ohm, for all units.

Photograph A-15: Post-test view of test unit 1 interior

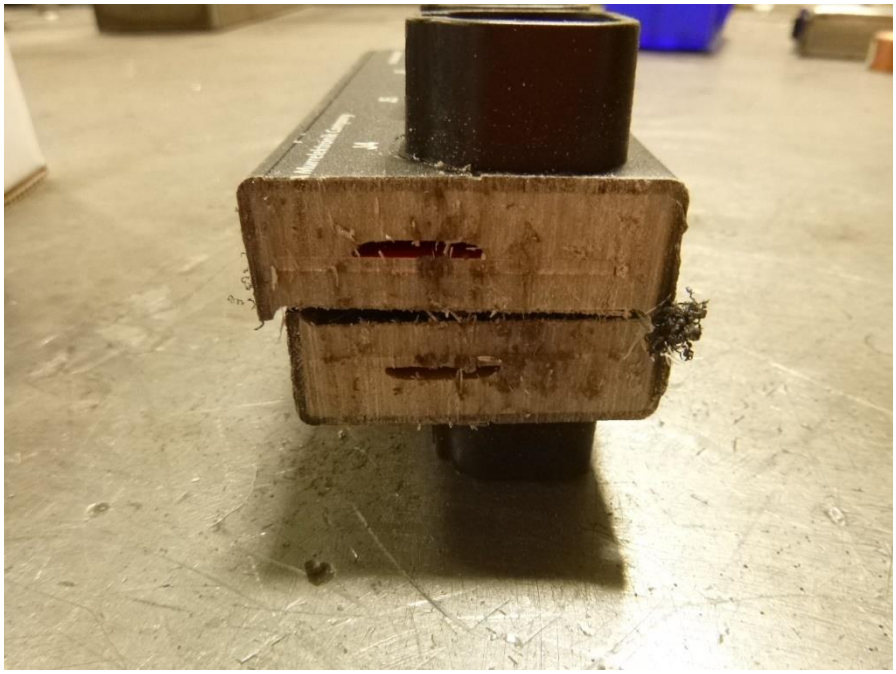
Photograph A-18: Post-test view of test unit 2 interior

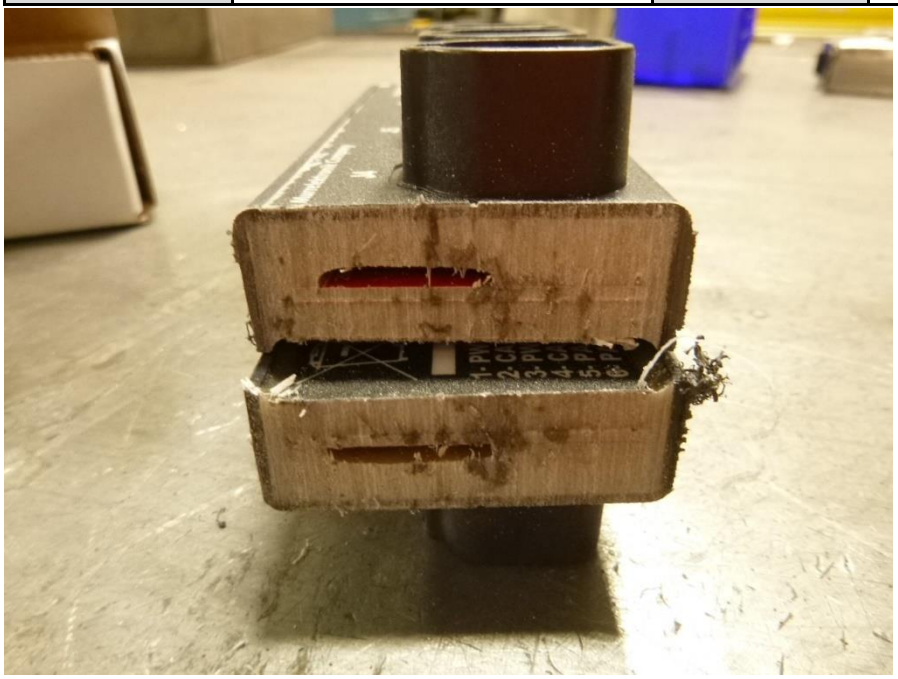
Photograph A-21: Post-test view of test unit 3 interior

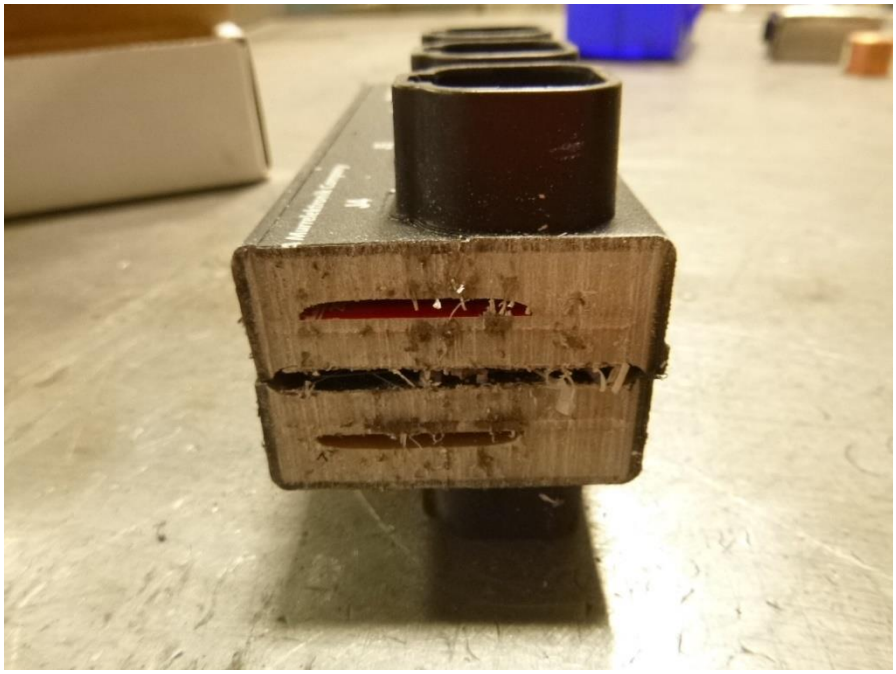
Photograph A-24: Post-test view of test unit 4 interior
